■ TROUBLESHOOTING

12. JAM CODE

bizhub PRO 950

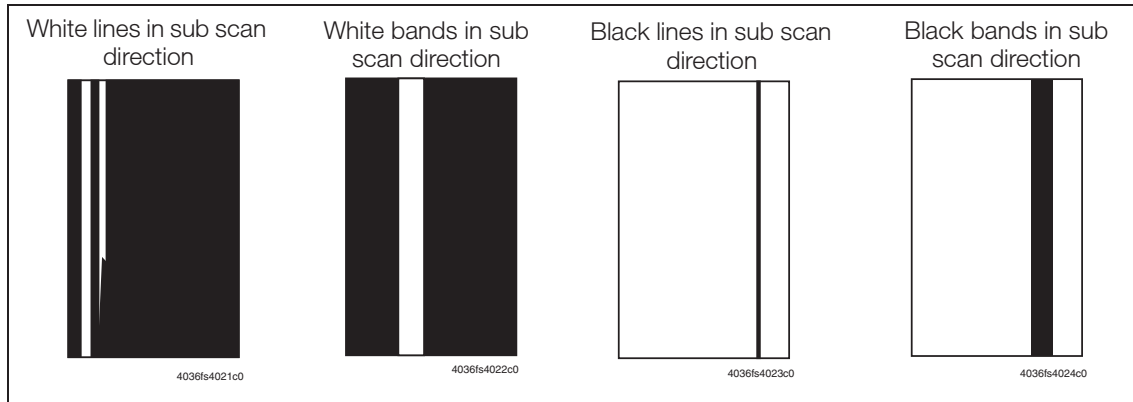
A. Typical faulty images

15.2.3 Printer system: White lines in sub scan direction, White bands in sub scan direction, Black lines in sub scan direction, Black bands in sub scan direction

Step	Section	Check item	Result	Action
1	Paper	It occurs on the particular paper.	YES	Check the setting of the paper type.
2	Check the image	There are sharp white lines or black lines in the main scan direction.	YES	Clean the charging wire, the charging control plate, and the transferring wire.
3	Writing section	Dust-proof glass has dirt.	YES	Clean the dust-proof glass.
4	Check the printer	Check mainly on the charging section, transferring section, photo conductor section, developing section and the conveyance section.	NO	Clean, Replace
5	Cleaning section	Some parts on the cleaning blade are left to wipe.	YES	Clean Replace the cleaning blade
6	Photo conductor section	Drum claw has dirt.	YES	Clean Check the drum claw action
7	Fusing section	Fusing claw has dirt.	YES	Clean Check the fusing claw action
8	Image Stabilization	The image stabilization solves the trouble.	NO	Go on to the next step.
9	Connector, wiring	There is no problem on the overall control board, write section, connector of the printer control board, and the wiring.	NO	Reconnect the connector Replace the wiring

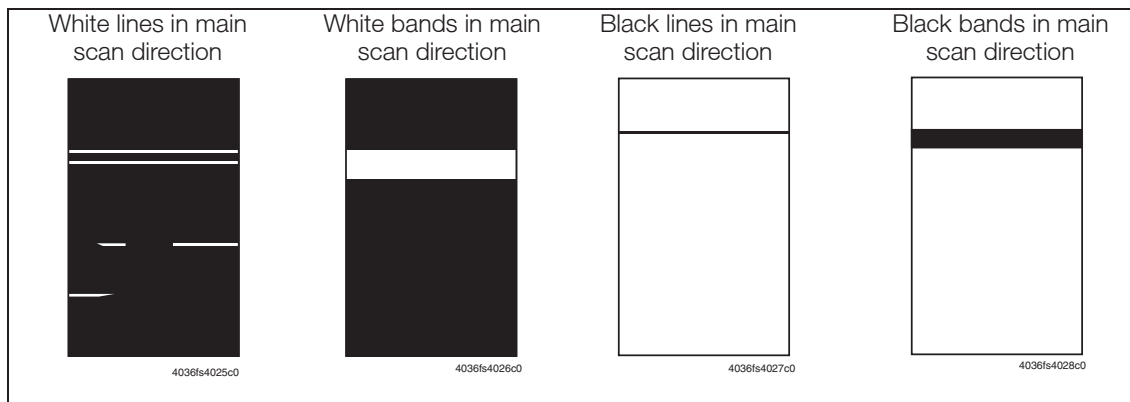
A. Typical faulty images

15.2.4 Printer system: White lines in main scan direction, White bands in main scan direction, Black lines in main scan direction, Black bands in main scan direction

Step	Section	Check item	Result	Action
1	Paper	It occurs on the particular paper.	YES	Check the setting of the paper type.
2	Check the printer	Check mainly on the charging section, transferring section, photo conductor section, developing section and the fusing section.	NO	Clean, Replace
3	Image Stabilization	The image stabilization solves the trouble.	NO	Go on to the next step.
4	Cleaning section	Some parts on the cleaning blade are left to wipe.	YES	Clean Replace the cleaning blade
5	Connector, wiring	There is no problem on the overall control board, write section, connector of the printer control board, and the wiring.	NO	Reconnect the connector Replace the wiring
6		The problem has been solved by step 5.	NO	Check or replace the charging section → Replace the drum → Check or replace the transferring section → Check or replace the developing section → Replace the write section → Replace the printer control board

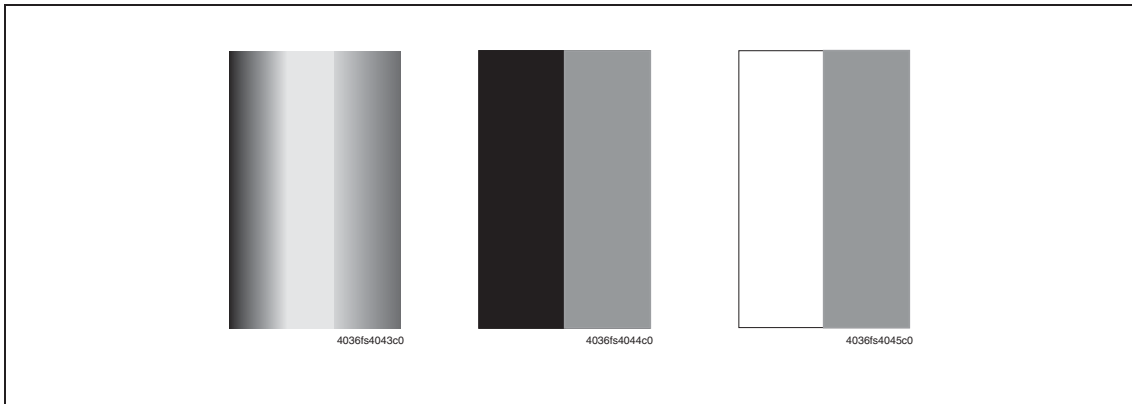
A. Typical faulty images

15.2.5 Printer system: Uneven density in sub scan direction

Step	Section	Check item	Result	Action
1	Paper	It occurs on the particular paper.	YES	Check the setting of the paper type.
2	Check the printer	Check mainly on the charging section, transferring section, photo conductor section, and the developing section.	NO	Clean, Replace
3	Service mode → Process adjustment → Drum peculiarity Adj. → LD Offset Adjustment	LD offset adjustment has been conducted and the trouble is solved.	NO	Go on to the next step.
4	Image Stabilization	The image stabilization solves the trouble.	NO	Go on to the next step.
5	Setting menu → Function Setting → Density Setting → Image Density Selection	Check the setting value of the image density.	YES	Change the setting value to the plus.
6	Connector, wiring	There is no problem on the overall control board, write section, connector of the printer control board, and the wiring.	NO	Reconnect the connector Replace the wiring
7		The problem has been solved by step 6.	NO	Check or replace the charging section → Replace the drum → Check or replace the transferring section → Check or replace the developing section → Replace the write section → Replace the printer control board → Replace the high voltage unit /2

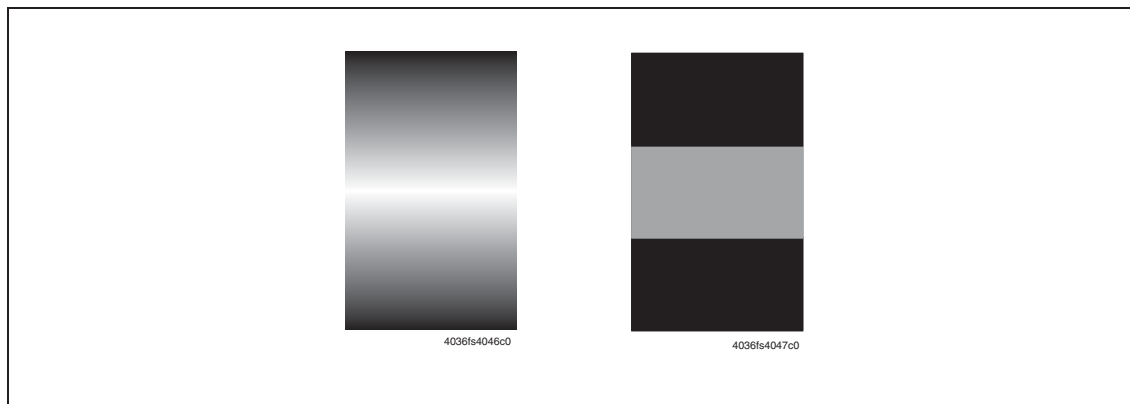
A. Typical faulty images

15.2.6 Printer system: Uneven density in main scan direction

Step	Section	Check item	Result	Action
1	Paper	It occurs on the particular paper.	YES	Check the setting of the paper type.
2	Check the printer	Check mainly on the charging section, transferring section, photo conductor section, and the developing section.	NO	Clean, Replace
3	Service mode → Process adjustment → Drum peculiarity adjustment → LD offset adjustment	LD offset adjustment has been conducted and the trouble is solved.	NO	Go on to the next step.
4	Image Stabilization	The image stabilization solves the trouble.	NO	Go on to the next step.
5	Setting menu → Function Setting → Density Setting → Image Density Selection	Check the setting value of the image density.	YES	Change the setting value to the plus.
6	Connector, wiring	There is no problem on the overall control board, write section, connector of the printer control board, and the wiring.	NO	Reconnect the connector Replace the wiring
7		The problem has been solved by step 6.	NO	Check or replace the charging section → Replace the drum → Check or replace the transferring section → Check or replace the developing section → Replace the write section → Replace the printer control board → Replace the high voltage unit /1 → Replace the high voltage unit /2

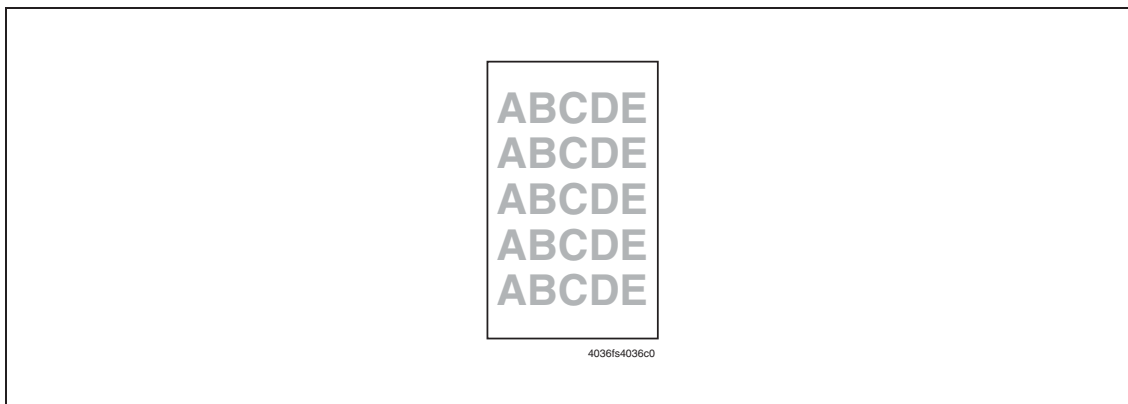
15.2.7 Printer system: Light density (ID lowering)**A. Typical faulty image**

Step	Section	Check item	Result	Action
1	Paper	It occurs on the particular paper.	YES	Check the setting of the paper type.
2	Check the printer	Check mainly on the charging section, transferring section, photo conductor section, and the developing section.	NO	Clean, Replace
3	Toner supply section	The setting of toner bottle is not enough.	YES	Reset
4	Counter clear	Counter clear has been conducted when the drum and the developer are replaced.	NO	Conduct the counter clear of the photo conductor and the developer.
5	IDC sensor	IDC sensor has dirt.	YES	Clean IDC sensor
6	Image Stabilization	The image stabilization solves the trouble.	NO	Go on to the next step.
7	Setting menu → Function Setting → Density Setting → Image Density Selection	Check the setting value of the image density.	YES	Change the setting value to the plus.
8	Individual support action adjustment → Image density adjustment	[Darker] on the image density adjustment solves the trouble.	NO	Go on to the next step.

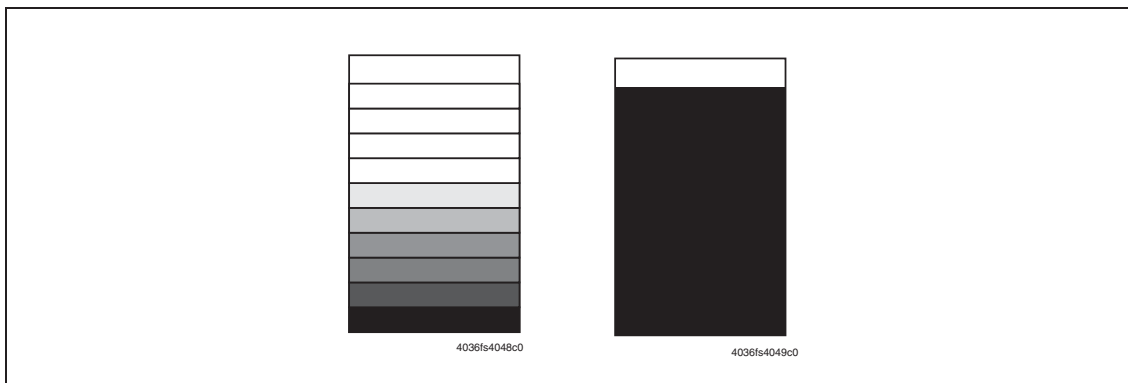
A. Typical faulty images

15.2.8 Printer system: Gradation error

Step	Section	Check item	Result	Action
1	Gradation pattern	Print out the test pattern No.3 or No.5 and the gradation pattern is without any trouble.	YES	Check the other density errors of the printer system.
2	Paper	It occurs on the particular paper.	YES	Check the setting of the paper type.
3	Density	It occurs on the particular image (such as picture).	NO	Check Copy Setting → Image Setting (letters, light letters, picture).
4	Check the printer	Check mainly on the charging section, transferring section, photo conductor section, and the developing section.	NO	Clean, Replace
5	Image Stabilization	The image stabilization solves the trouble.	NO	Go on to the next step.
6	Setting menu → Function Setting → Density Setting → Image Density Selection	Check the setting value of the image density.	YES	If the density is too light, change the setting value to the plus. If the density is too dark, change the setting value to the minus.

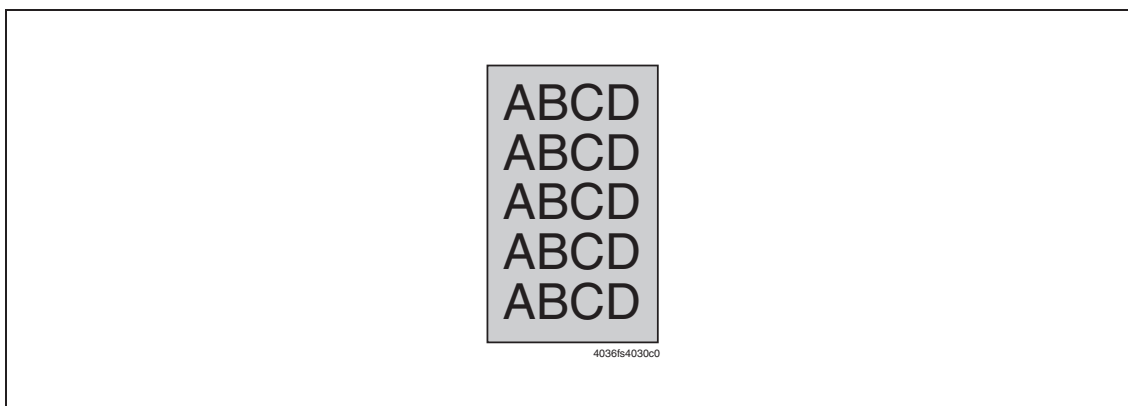
A. Typical faulty image

15.2.9 Printer system: Gray background

Step	Section	Check item	Result	Action
1	Paper	It occurs on the particular paper.	YES	Check the setting of the paper type.
2	Setting menu → Function Setting → Density Setting	Check the setting value of [Image Density Selection].	YES	Change the setting value to the minus.
3	Check the printer	Check mainly on the charging section, transferring section, photo conductor section, developing section, write section.	NO	Clean, Replace
4	Image Stabilization	The image stabilization solves the trouble.	NO	Go on to the next step.
5	Service mode → System setting → Software DIPSW_27-2/3	Changing the image density lighter solves the trouble.	NO	Go on to the next step.
6	Service mode → System setting → Software DIPSW_23-2/3/4	Changing the toner density lighter solves the trouble.	NO	Go on to the next step.
7	Connector, wiring	There is no problem on the overall control board, write section, connector of the printer control board, and the wiring.	NO	Reconnect the connector Replace the wiring

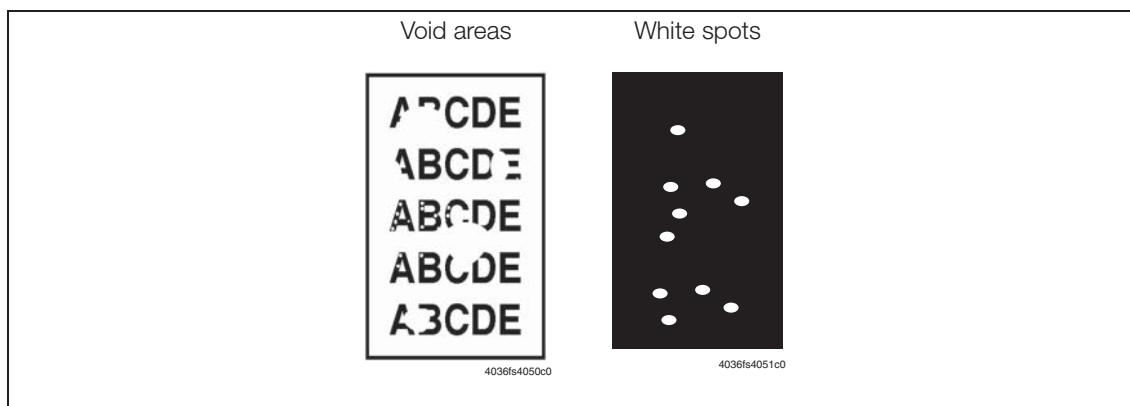
A. Typical faulty images

15.2.10 Printer system: Void areas, White spots

Step	Section	Check item	Result	Action
1	Paper	It occurs on the particular paper.	YES	Check the setting of the paper type.
2	Check the printer	Check mainly on the charging section, transferring section, photo conductor section, developing section and the fusing section.	NO	Clean, Replace
3	Image Stabilization	The image stabilization solves the trouble.	NO	Go on to the next step.
4	Service mode → System setting → Software DIPSW_27-2/3	Changing the image density darker solves the trouble.	NO	Go on to the next step.
5	Service mode → System setting → Software DIPSW_23-2/3/4	Changing the toner density darker solves the trouble.	NO	Go on to the next step.
6	Developing section	Developing section has the foreign object or the solid toner in it.	YES	Remove foreign object Replace developer
7	Connector, wiring	There is no problem on the overall control board, write section, connector of the printer control board, and the wiring.	NO	Reconnect the connector Replace the wiring

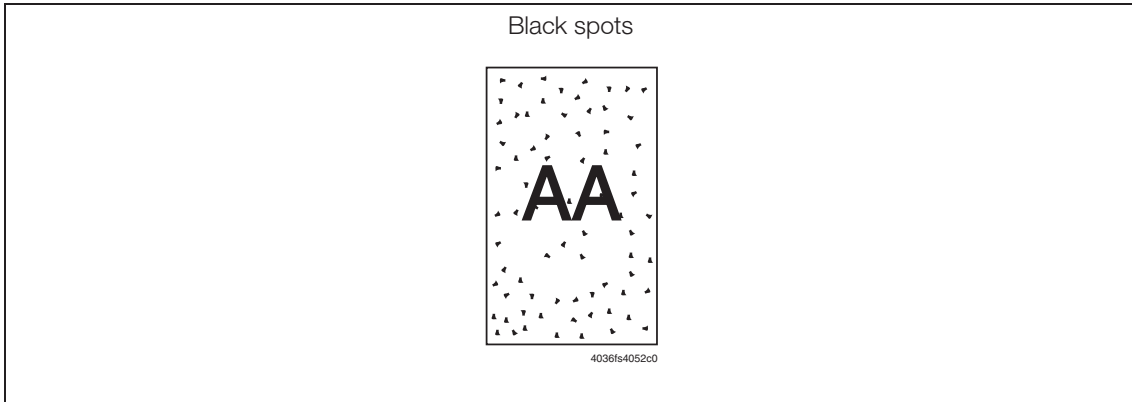
15.2.11 Printer system: Black spots**A. Typical faulty image**

Step	Section	Check item	Result	Action
1	Check the printer	Check mainly on the charging section, transferring section, photo conductor section, developing section, conveyance section, and the fusing section.	NO	Clean, Replace
2	Photo conductor section	Conducting the cartridge set mode solves the trouble.	NO	Go on to the next step.
3	Image Stabilization	The image stabilization solves the trouble.	NO	Go on to the next step.
4	Service mode → System setting → Software DIPSW_27-2/3	Changing the image density lighter solves the trouble.	NO	Go on to the next step.
5	Service mode → System setting → Software DIPSW_23-2/3/4	Changing the toner density lighter solves the trouble.	NO	Go on to the next step.
6	Connector, wiring	There is no problem on the overall control board, write section, connector of the printer control board, and the wiring.	NO	Reconnect the connector Replace the wiring
7		The problem has been solved by step 6.	NO	Check or replace the charging section → Replace the drum → Check or replace the transferring section → Check or replace the developing section → Replace the write section

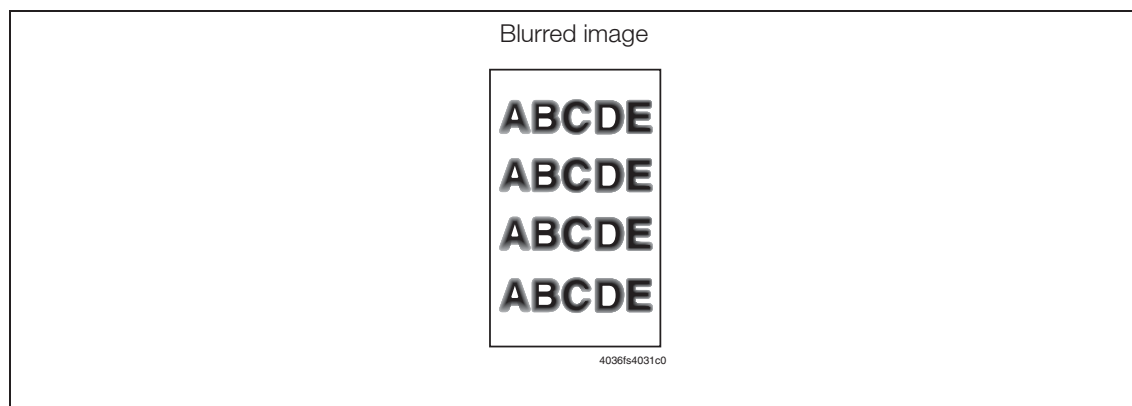
A. Typical faulty image

15.2.12 Printer system: Image blurring

Step	Section	Check item	Result	Action
1	Paper	It occurs on the particular paper.	YES	Check the setting of the paper type.
2	Check the printer	Check mainly on the charging section, transferring section, photo conductor section, developing section, and write section.	NO	Clean, Replace
3	Image Stabilization	The image stabilization solves the trouble.	NO	Go on to the next step.
4	Connector, wiring	There is no problem on the overall control board, write section, connector of the printer control board, and the wiring.	NO	Reconnect the connector Replace the wiring
5		The problem has been solved by step 4.	NO	Check or replace the charging section → Replace the drum → Check or replace the transferring section → Check or replace the developing section → Replace the write section → Replace the printer control board

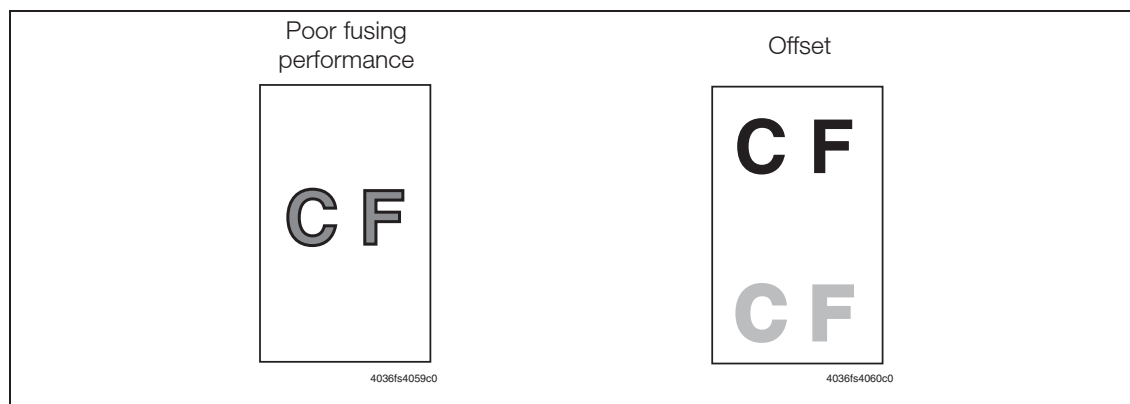
A. Typical faulty images

15.2.13 Printer system: Poor fusing performance, Offset

Step	Section	Check item	Result	Action
1	Paper	It occurs on the particular paper.	YES	Check the setting of the paper type.
2	Check the printer	Check mainly on the cleaning section and the fusing section.	NO	Clean, Replace
3	Image Stabilization	The image stabilization solves the trouble.	NO	Go on to the next step.
4	Cleaning section (Offset)	Some parts on the cleaning blade are left to wipe.	YES	Clean Replace the cleaning blade
5	Fusing section	The fusing temperature sensor is installed properly.	NO	Check the installation position.
6	Service mode → System setting → Software DIPSW_19-0 to 3	Changing the fusing temperature eliminates the poor fusing performance and the offset.	YES	Conduct the fusing temperature adjustment.
7	Connector, wiring	There is no problem on the connector of the printer control board, and the wiring.	NO	Reconnect the connector Replace the wiring
8		The problem has been solved by step 7.	NO	Fusing temperature sensor → Replace the fusing heater lamp → Replace the printer control board

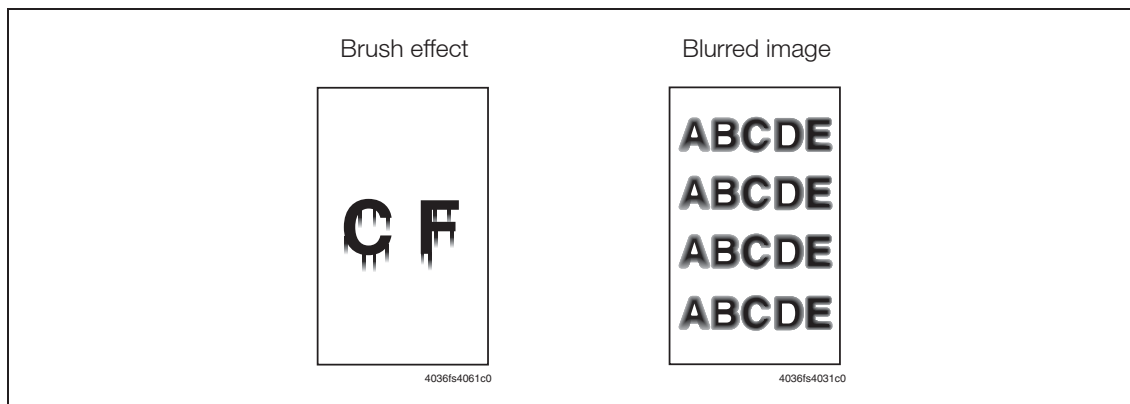
A. Typical faulty images

15.2.14 Printer system: Brush effect, Image bleeding

Step	Section	Check item	Result	Action
1	Paper	Paper is moisturized.	YES	Replace to the paper that has just opened.
2		It occurs on the particular paper.	YES	Check the setting of the paper type.
3	Check the printer	Check mainly on the fusing section and conveyance section.	NO	Clean, Replace
4	Image Stabilization	The image stabilization solves the trouble.	NO	Go on to the next step.
5	Fusing section	The cleaning web cleans properly.	NO	Check the cleaning web Replace the cleaning web
6	Connector, wiring	There is no problem on the connector of the printer control board, and the wiring.	NO	Reconnect the connector Replace the wiring
7		The problem has been solved by step 6.	NO	Fusing temperature sensor → Replace the fusing heater lamp → Replace the printer control board

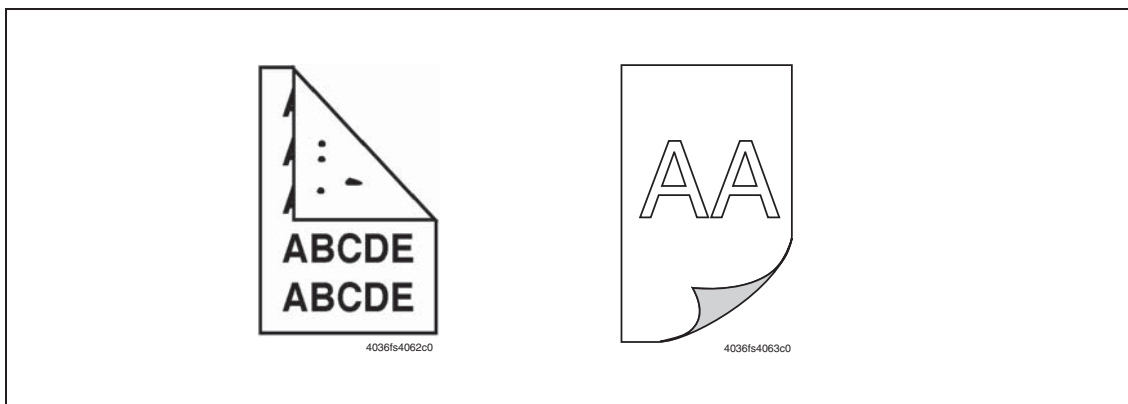
A. Typical faulty images

15.2.15 Printer system: Inky backside

Step	Section	Check item	Result	Action
1	Paper path	There are foreign objects or dirt on the paper path.	YES	Remove the foreign object or dirt
2	Check the printer	Check mainly on the transferring section, conveyance section, and the fusing section.	NO	Clean, Replace
3	Image Stabilization	The image stabilization solves the trouble.	NO	Go on to the next step.
4	Fusing section	Fusing guide plate has dirt.	YES	Remove dirt
5		Fusing roller /Lw has the damage or dirt.	YES	Replace the fusing roller /Lw
6	Connector, wiring	There is no problem on the connector of the printer control board, and the wiring.	NO	Reconnect the connector Replace the wiring
7		The problem has been solved by step 6.	NO	Check or replace the transferring section → Replace the printer control board → Replace the high voltage unit /2

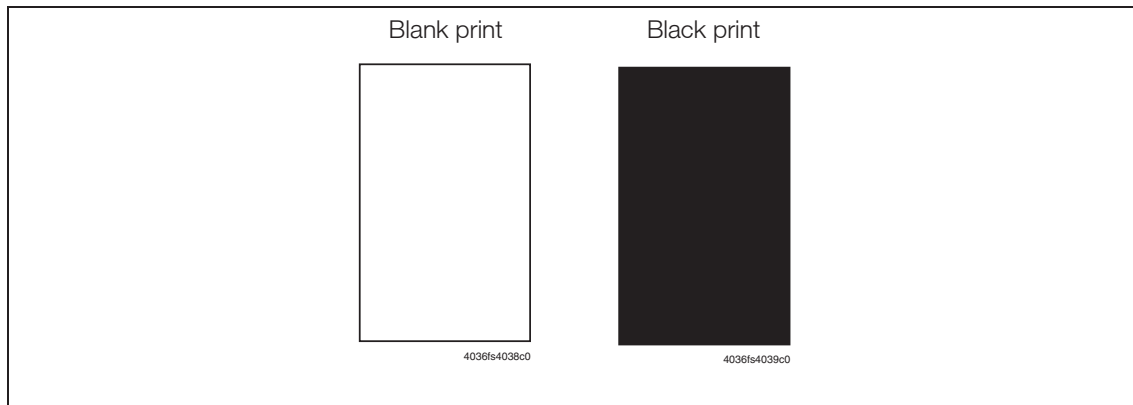
15.2.16 Printer system: Blank print, Black print**A. Typical faulty images**

Step	Section	Check item	Result	Action
1	Check the image	Blank print occurs.	YES	Check the connection of the connector on the write unit.
2	Check the printer	Check mainly on the charging section, transferring section, photo conductor section, developing section, and write section.	NO	Clean, Replace
3	Image Stabilization	The image stabilization solves the trouble.	NO	Go on to the next step.
4	Connector, wiring	There is no problem on the overall control board, write section, connector of the printer control board, and the wiring.	NO	Reconnect the connector Replace the wiring
5		The problem has been solved by step 4.	NO	Check or replace the charging section → Check or replace the transferring section → Check or replace the developing section → Replace the write unit → Replace the printer control board → Replace the overall control board → Replace the high voltage unit /1 → Replace the high voltage unit /2

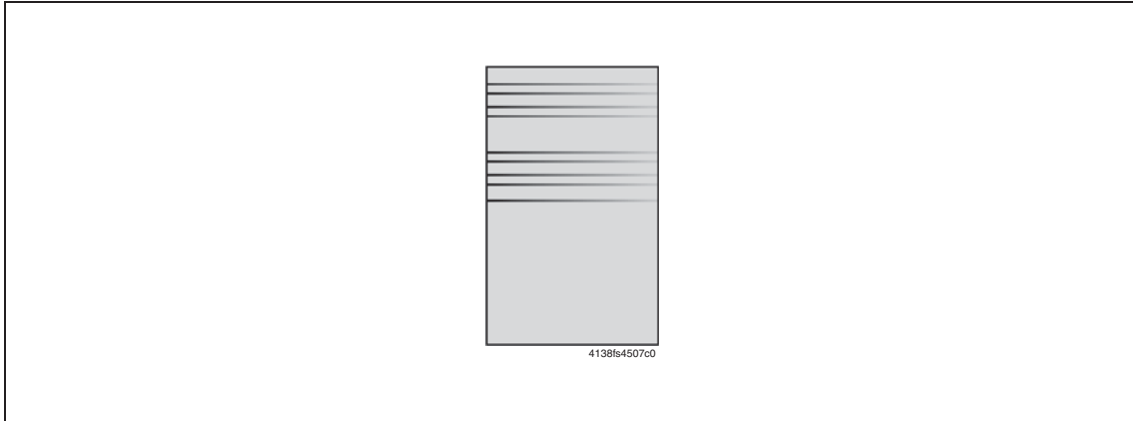
15.2.17 Printer system: Pitch unevenness**A. Typical faulty image**

Step	Section	Check item	Result	Action
1	Paper	It occurs on the particular paper.	YES	Check the setting of the paper type.
2	Check the printer	Check mainly on the charging section, transferring section, photo conductor section, developing section, write section, and the fusing section.	NO	Clean, Replace
3	Image Stabilization	The image stabilization solves the trouble.	NO	Go on to the next step.
4	Service mode → Registration Line Speed (Magnification Adjustment) → Printer S1 FD-Mag. Adj.	Magnification adjustment solves the trouble.	NO	Go on to the next step.
5	Connector, wiring	There is no problem on the overall control board, write section, connector of the printer control board, and the wiring.	NO	Reconnect the connector Replace the wiring
6		The problem has been solved by step 5.	NO	Check or replace the charging section → Check or replace the transferring section → Check or replace the developing section → Replace the write unit

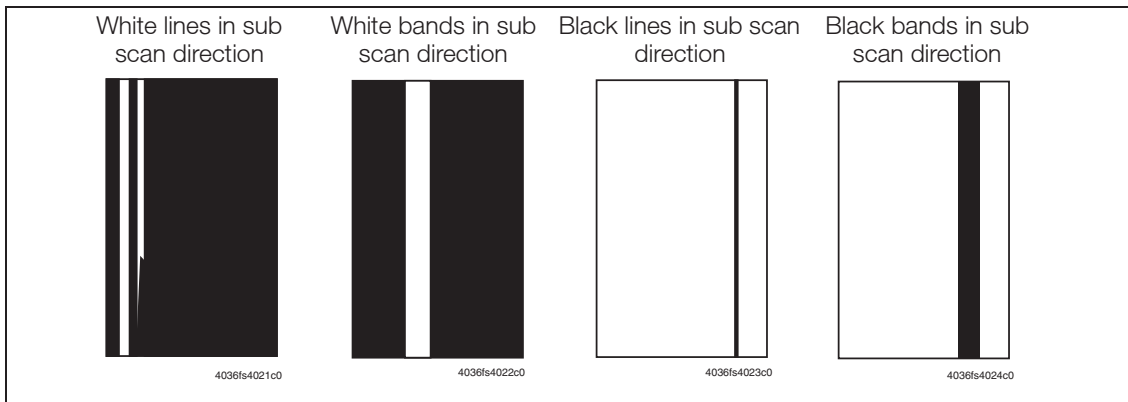
A. Typical faulty images

15.3.2 Scanner system: White lines in sub scan direction, White bands in sub scan direction, Black lines in sub scan direction, Black bands in sub scan direction

Step	Section	Check item	Result	Action
1	Scanner check	There is no problem on scanner check items.	NO	Clean, Replace
2	Service mode → Machine adjustment → Centering adjustment	The adjustment value of [Scanner Centering Adj.] is within the standard.	NO	Readjustment
3		The problem has been solved by step 2.	NO	Replace exposure unit → Replace CCD unit

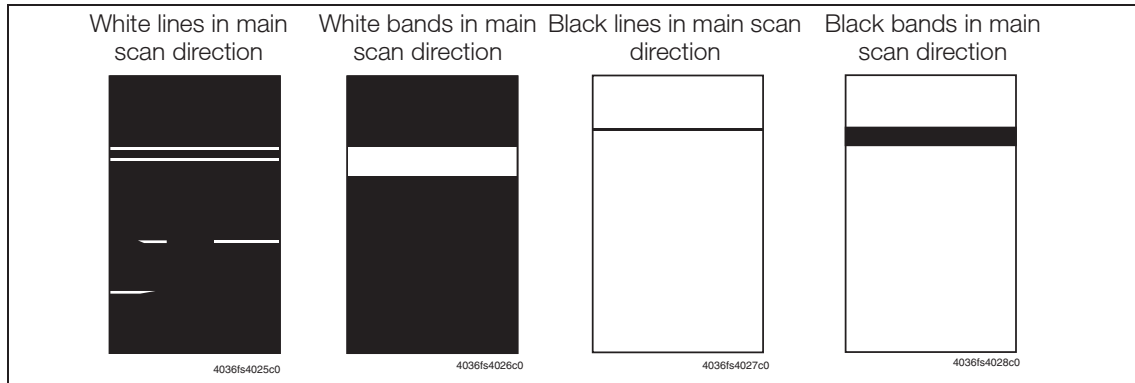
A. Typical faulty images

15.3.3 Scanner system: White lines in main scan direction, White bands in main scan direction, Black lines in main scan direction, Black bands in main scan direction

Step	Section	Check item	Result	Action
1	Scanner check	There is no problem on scanner check items.	NO	Clean, Replace
2	Service mode → Machine Adjustment → Timing Adjustment	The adjustment value of [Scanner Restart Timing] is within the standard.	NO	Readjustment
3	Service mode → Machine Adjustment → Centering Adjustment	The adjustment value of [Scanner Centering Adj.] is within the standard.	NO	Readjustment
4		The problem has been solved by step 3.	NO	Replace exposure unit → Replace CCD unit

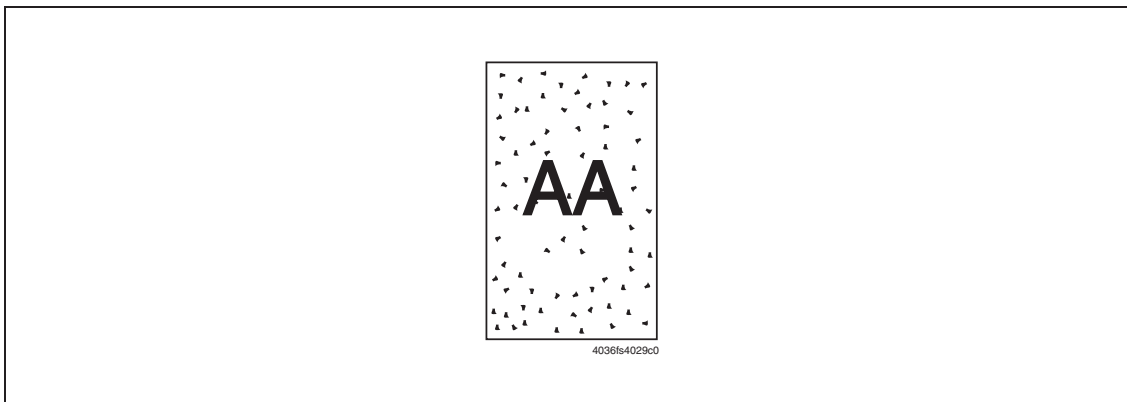
A. Typical faulty image

15.3.4 Scanner system: Black spots

Step	Section	Check item	Result	Action
1	Scanner check	There is no problem on scanner check items.	NO	Clean, Replace
2		The problem is solved with step 1.	NO	Replace exposure unit → Replace CCD unit

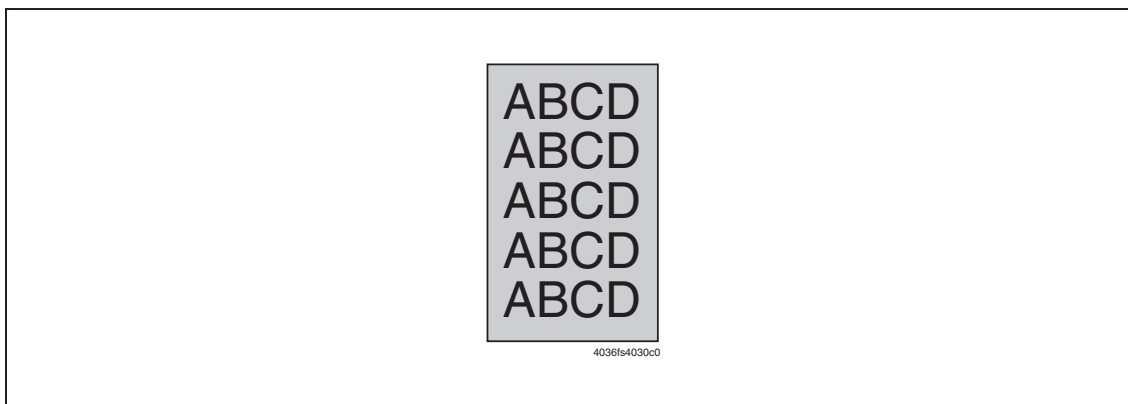
15.3.5 Scanner system: Gray background**A. Typical faulty image**

Step	Section	Check item	Result	Action
1	Scanner check	There is no problem on scanner check items.	NO	Clean, Replace
2	DF unit	DF unit changes the shape or the hinge is damaged.	YES	Replace DF unit
3	Mechanical adjustment → DF-616 → Height adjustment	DF unit is not at proper position.	YES	Readjustment
4		The problem has been solved by step 3.	NO	Replace exposure unit → Replace CCD unit

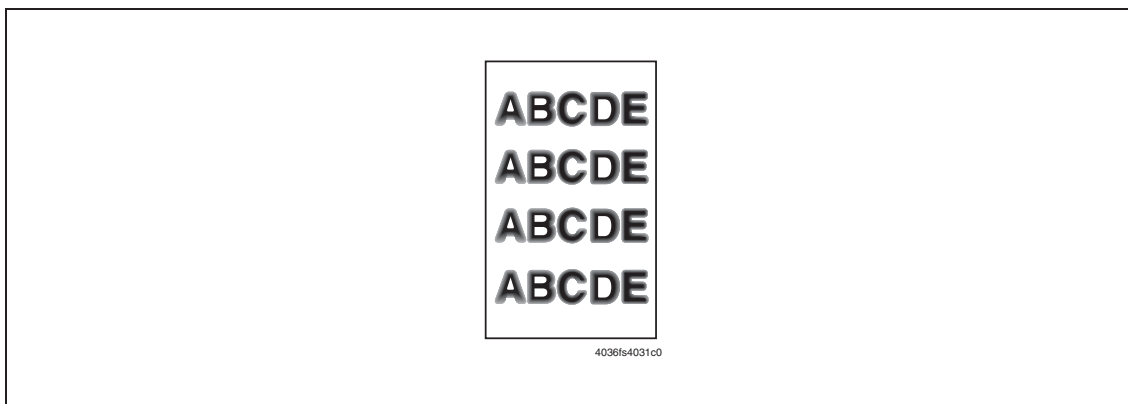
15.3.6 Scanner system: Blurred image, Brush effect**A. Typical faulty image**

Step	Section	Check item	Result	Action
1	Original	Original has bumps.	YES	Original change
2	DF unit	DF unit changes the shape or the hinge is damaged.	YES	Replace DF unit
3	Mechanical adjustment → DF-616 → Height adjustment	DF unit is not at proper position.	YES	Readjustment
4	Scanner check	There is no problem on scanner check items.	NO	Clean, Replace
5	Scanner section	Original glass leans or is not at proper position.	YES	Install it at proper position.
6		The install positions of V-mirror unit and the exposure unit are proper.	NO	Conduct the readjustment with using the optics unit positioning jig.
7		The problem has been solved by step 6.	NO	Replace exposure unit → Replace CCD unit

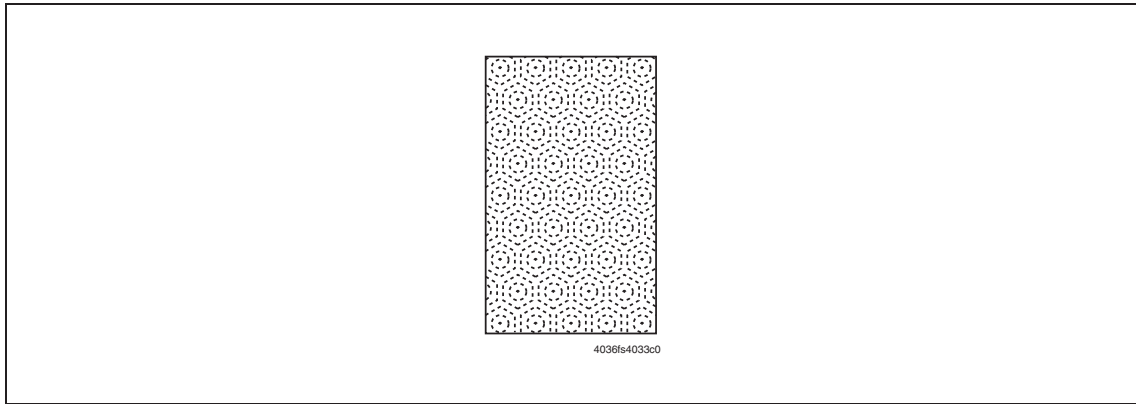
15.3.7 Scanner system: Moire**A. Typical faulty image**

Step	Section	Check item	Result	Action
1	Original	Moire does not occur after changing the direction of original set.	YES	Original set direction change
2	Basic setting → Quality Adj.	Moire does not occur after changing the quality of the original.	YES	Change to the other types of original (Text, Text/Photo, Photo).
3	Basic screen → Zoom	Changing the magnification solves moire.	YES	Change the magnification.
4		The problem has been solved by step 3.	NO	Replace CCD unit

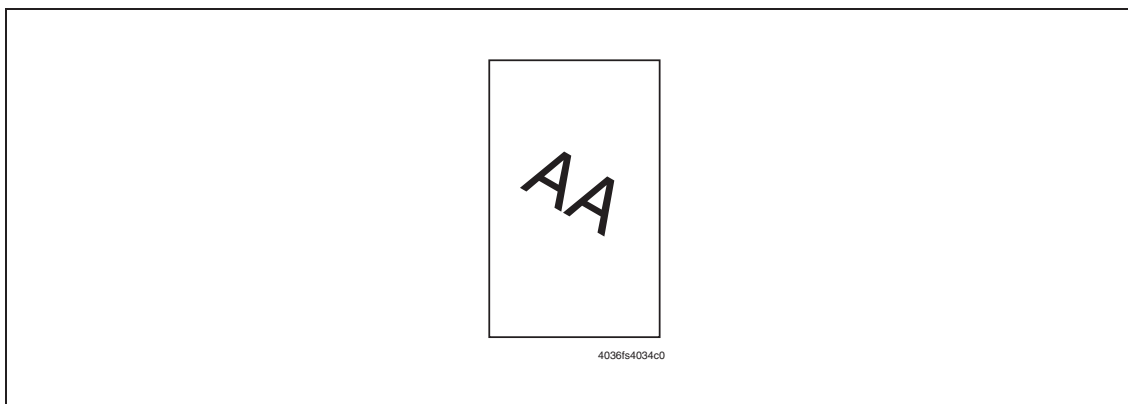
15.3.8 Scanner system: Leaning image**A. Typical faulty image**

Step	Section	Check item	Result	Action
1	Original	Original is leaning.	YES	Setting original Replace original
2	Scanner check	There is no problem on scanner check items.	NO	Clean, Replace
3	Scanner section	Original glass leans or is not at proper position.	YES	Install it at proper position.
4		The install positions of V-mirror unit and the exposure unit are proper.	NO	Conduct the readjustment with using the optics unit positioning jig.
5		The problem has been solved by step 4.	NO	Replace exposure unit → Replace CCD unit

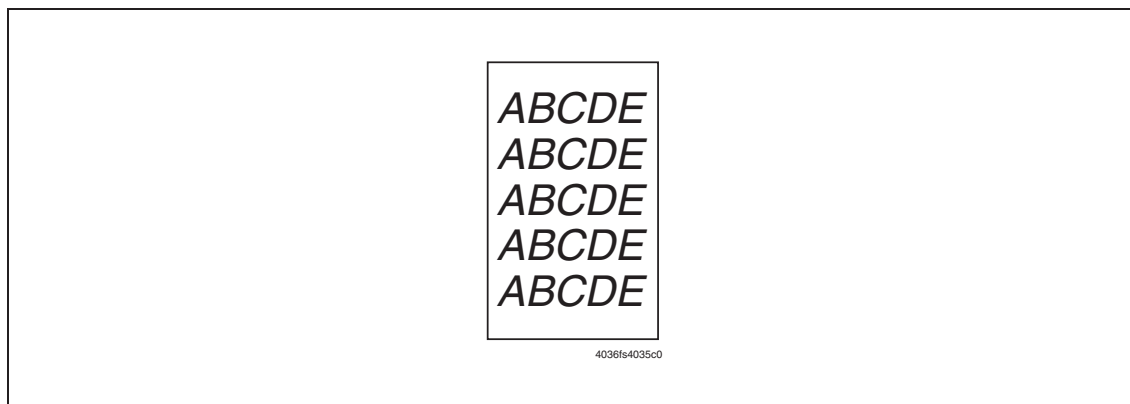
15.3.9 Scanner system: Image distortion**A. Typical faulty image**

Step	Section	Check item	Result	Action
1	State of the machine installed	The main body is installed on the horizontal place.	NO	Re-install
2	Scanner check	There is no problem on scanner check items.	NO	Clean, Replace
3	Service mode → Machine Adjustment → Distortion Adjustment	Adjusting each items solves the trouble.	NO	Readjustment
4	Scanner section	The install positions of V-mirror unit and the exposure unit are proper.	NO	Conduct the readjustment with using the optics unit positioning jig.
5		The problem has been solved by step 4.	NO	Replace exposure unit → Replace CCD unit

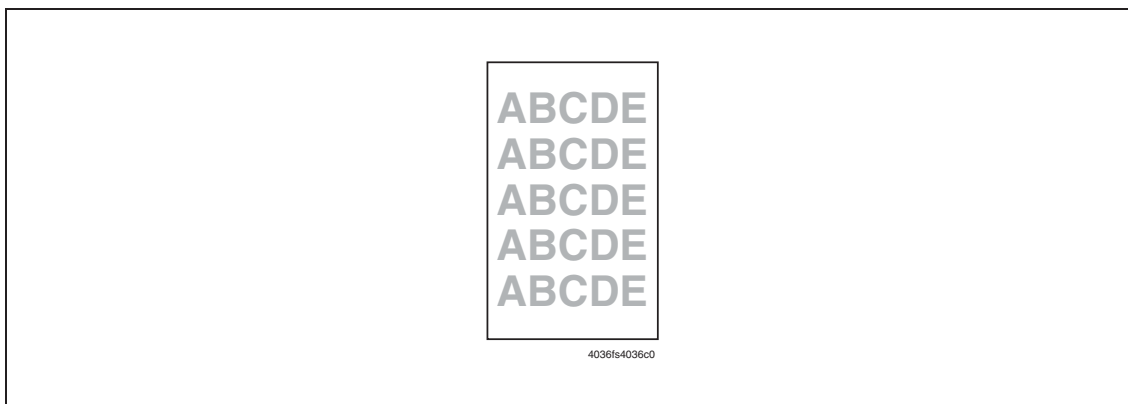
15.3.10 Scanner system: Low image density, Rough image**A. Typical faulty image**

Step	Section	Check item	Result	Action
1	Scanner check	There is no problem on scanner check items.	NO	Clean, Replace
2	Scanner section	Exposure lamp has dirt.	YES	Clean
3		The problem has been solved by step 2.	NO	Replace exposure unit → Replace CCD unit

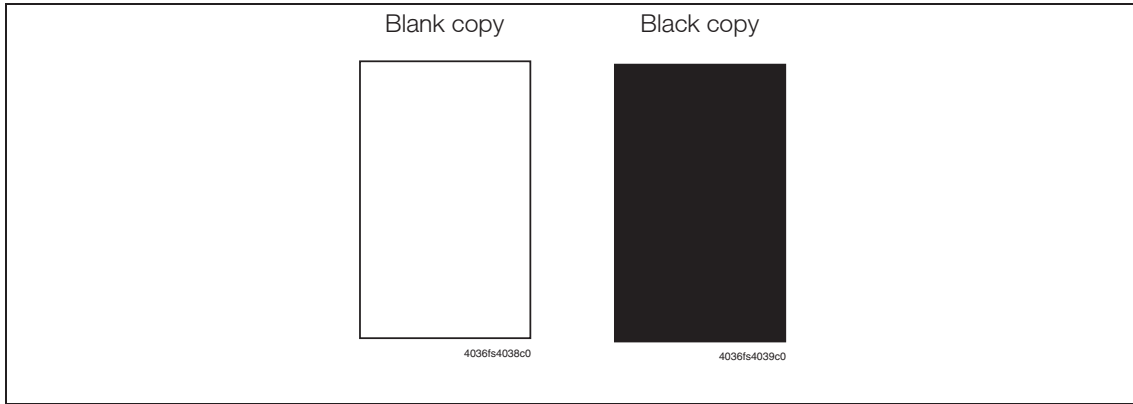
A. Typical faulty images

15.3.11 Scanner system: Blank copy, Black copy

Step	Section	Check item	Result	Action
1	Gradation pattern	Print out the test pattern No.3 or No.5 and the gradation pattern is without any trouble.	NO	Check the image trouble of the printer system.
2	Scanner check	There is no problem on scanner check items.	NO	Clean, Replace
3	Connector, wiring	There is no trouble on CCD unit, connector of the overall control board, and wiring.	NO	Reconnect the connector Replace the wiring
4		The problem has been solved by step 3.	NO	Replace CCD unit → Replace the overall control board

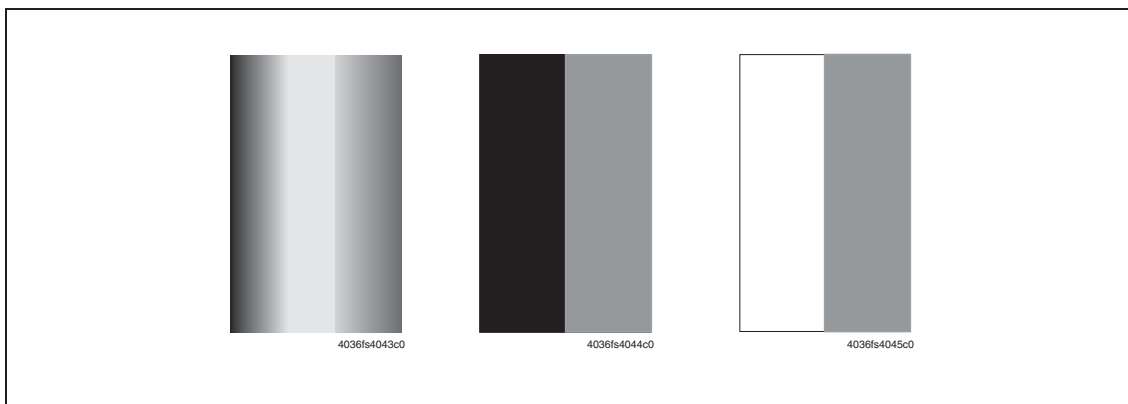
A. Typical faulty images

15.3.12 Scanner system: Uneven density

Step	Section	Check item	Result	Action
1	Scanner check	There is no problem on scanner check items.	NO	Clean, Replace
2	Scanner section	V-mirror unit and the exposure unit moves smoothly.	NO	Check the scanner wire
3		The install positions of V-mirror unit and the exposure unit are proper.	NO	Conduct the readjustment with using the optics unit positioning jig.
4		The problem has been solved by step 3.	NO	Replace exposure unit → Replace CCD unit

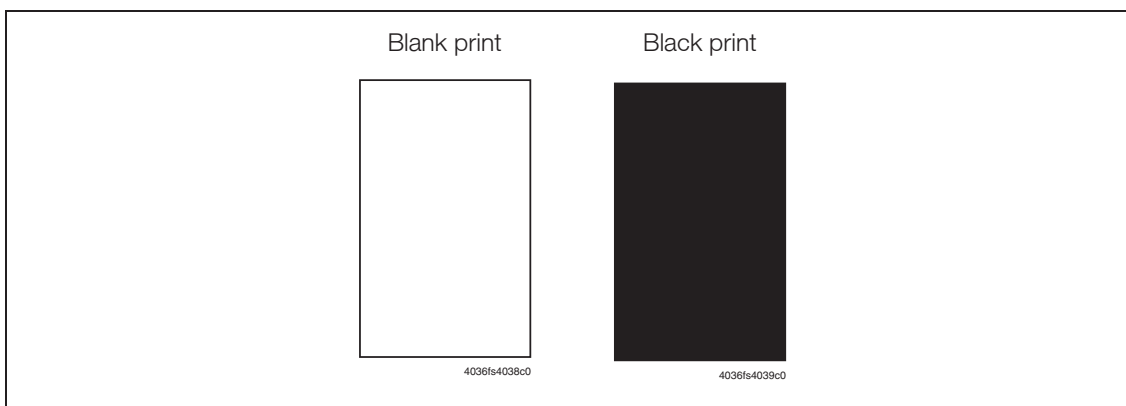
A. Typical faulty images

15.4.2 Controller system: Blank print, Black print

Step	Section	Check item	Result	Action
1	Controller Check	There is no problem on the controller check item.	NO	Recover the network connection
2	IC board (ICB)	Connector of IC board is surely set.	NO	Reconnect the connector
3	PCI relay board (PCIRB)	Connector on the PCI relay board is surely set.	NO	Reconnect the connector
4	Overall control board (OACB)	Connector of overall control board is surely set.	NO	Reconnect the connector
5		The problem has been solved by step 4.	NO	Replace IC board → Replace PCI relay board → Replace the overall control board
